Massachusetts Institute of Technology  
Charles Stark Draper Laboratory  
Cambridge, Massachusetts

LUMINARY MEMO # 155

DATE: 1 June 1970

SUBJECT: Luminary 1D re-release

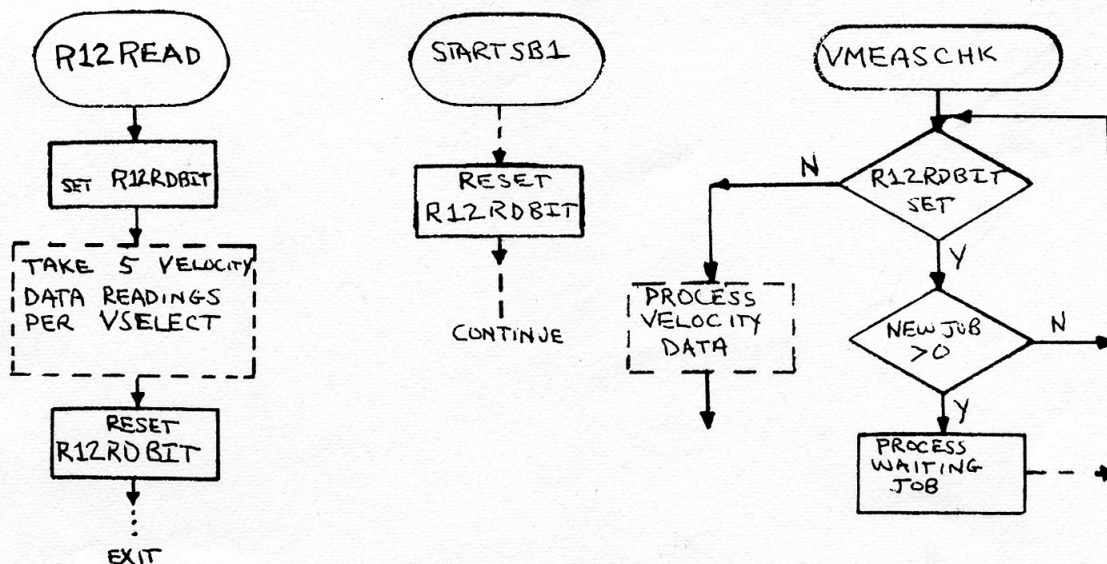
1. Implementation of ACB L 20-  
An error was made in reading assembly card numbers: 2234 vs 2334. By coincidence, they are concerned with the same noun (60) in the NOUN Tables (output and input scaling). The fix makes the output scaling 0.5571 fps/bit and the input scaling the way it was originally, though it is not intended for use.
2. Implementation of PCR 988-  
The Restart point in P66 was moved down four places to (1) prevent the AstrPro flag from being set by a Restart if it had been reset to turn off RCS jets (2) prevent a possible 1466 alarm if a P66 omission occurred with a Restart.
3. Implementation of PCR 896-  
(LMS/KSC). The landing Radar Velocity Reasonableness test could fail erroneously due to Service being too fast. It starts to process LR velocity data before the complete set of radar readings are taken for a particular velocity beam. The fix is flowed below.

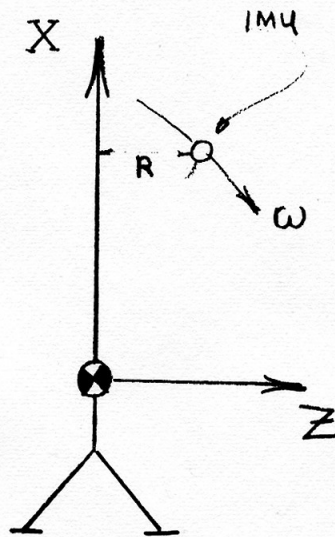
PCR 1052 was implemented into the re-release to account for the IMU sensing vertical acceleration in P66 when the PIPA's are read while Spacecraft attitude rate is present. The result before the PCR implementation was throttle oscillation commonly referred to as "throttle castellation." Now, when the present acceleration due to thrust is computed (i.e. the PIPA's are read in P66) the pitch rate as determined by the DAP (OMEGAQ) is multiplied by the offset distance the IMU is from the X axis in the Z direction. This quantity is a measure of the Delta Velocity sensed by the PIPA's due to the IMU rotating ("bobbing") around the center of gravity and is subtracted from the total Delta V measured by the PIPA's for that P66 one-second pass. Navigation is in no way affected by the bobbing or the correction.

$$\Delta V_x = \Delta V_x - \omega \cdot R$$
